Case 247 : Narrative

Case Vehicle (A): 1999 Ford
Type: Taurus SE, 4-door sedan
Driver: 24- year-old male
CDC: 12-LFES-1, 12-FCEN-3

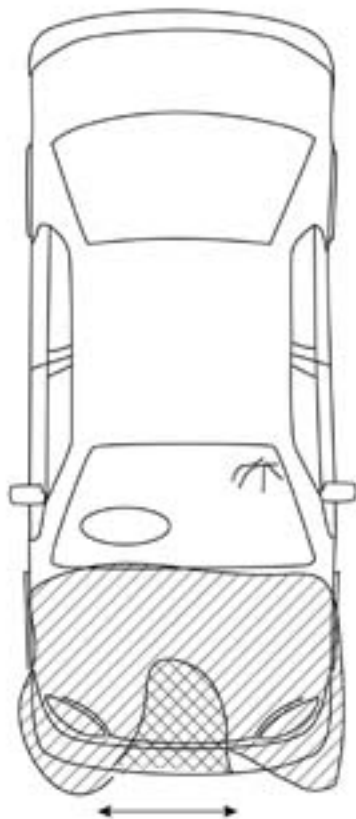
impact #2
19 cm direct damage
70 cm max crush

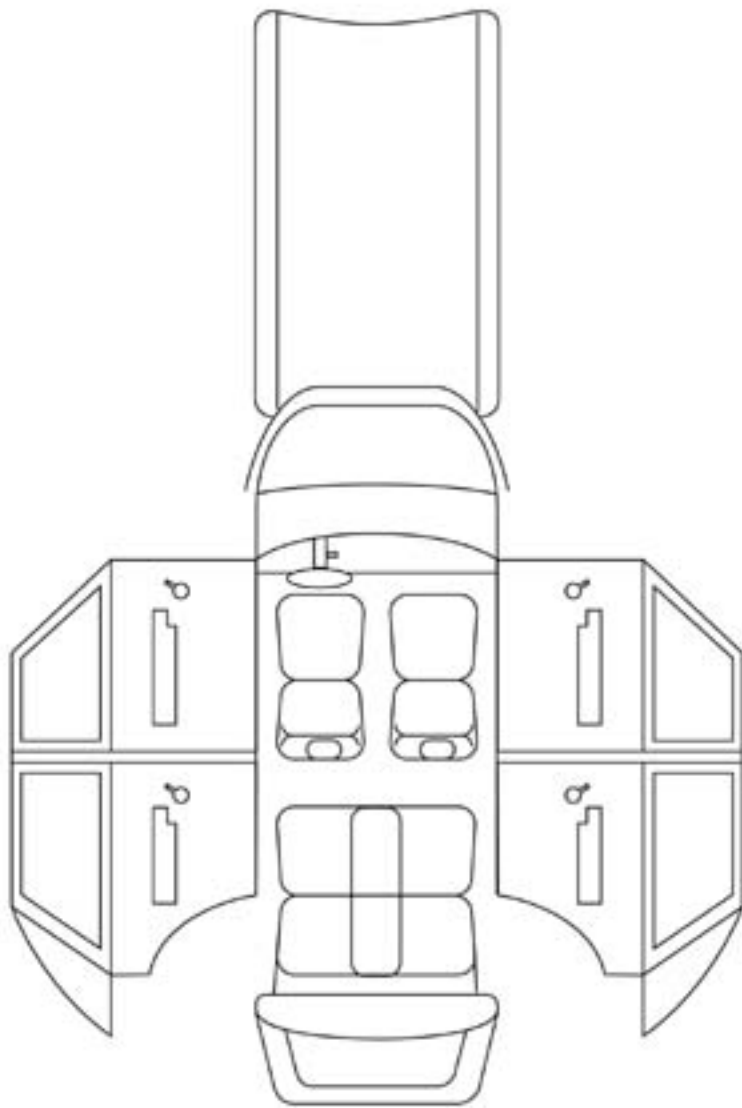
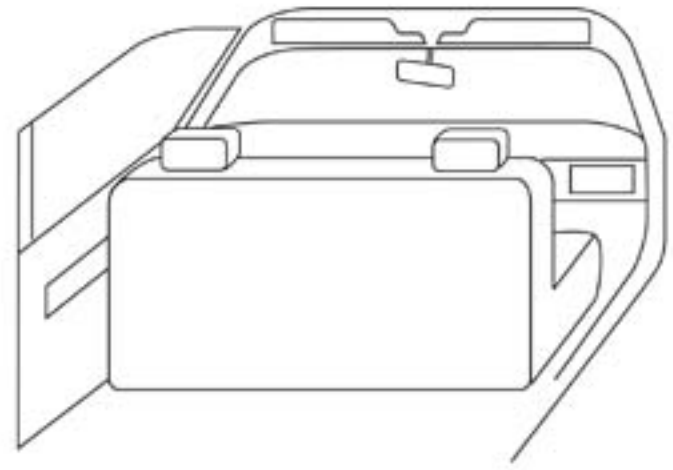
Belt evidence: plastic scraped on
D-ring, marks on webbing

good evidence of use, positioned
on up on B-pillar

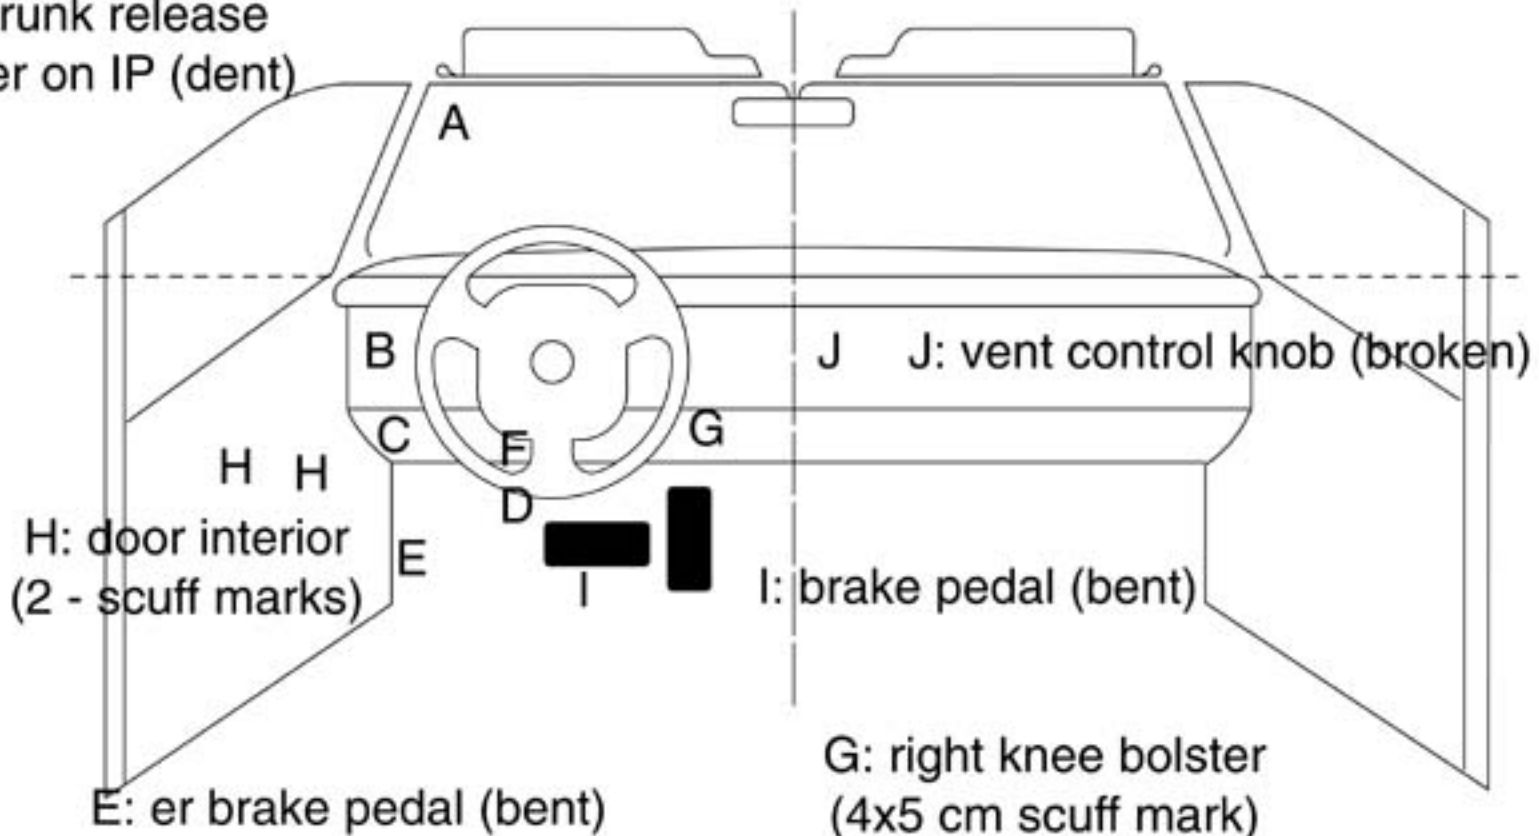
A: windshield (crack, arm hair)

C: trunk release
cover on IP (dent)

H: door interior
(2 - scuff marks)

E: er brake pedal (bent)

J: vent control knob (broken)
